# EXPLOSION AT HAPTON VALLEY COLLIERY, LANCASHIRE

On the causes of, and circumstances attending, the Explosion  
which occurred at Hapton Valley Colliery, Lancashire,  
on 22nd March, 1962

H.M. Chief Inspector of Mines and Quarries

*Presented to Parliament by the Minister of Power  
by Command of Her Majesty  
November, 1962*

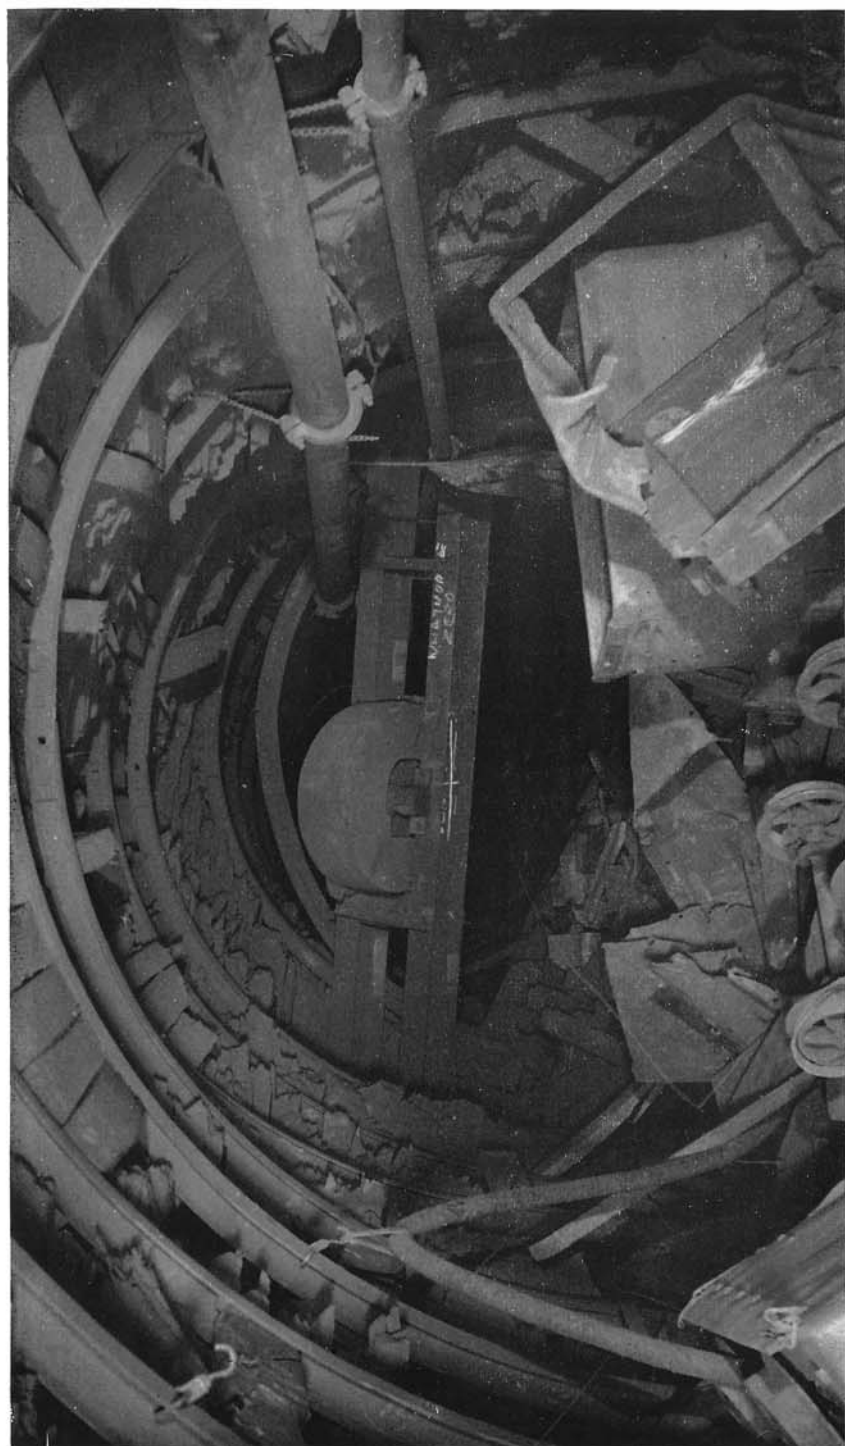
haulage. The wheel, the carrying frame and the arch girder supporting it had all been displaced in an outbye direction, but there was no sign of abrasion on the return wheel or its framework. Plates I and II show the damage in this area. For a further 200 yards outbye, signs of damage were much less in evidence, but there had evidently been strong blast some 650 yards from the ripping where a tank had been displaced. From there to the junction with No. 5 District return there were signs of only slight blast.

PLATE I. Wrecked tubs and bogies in return gate inbye of haulage return wheel.

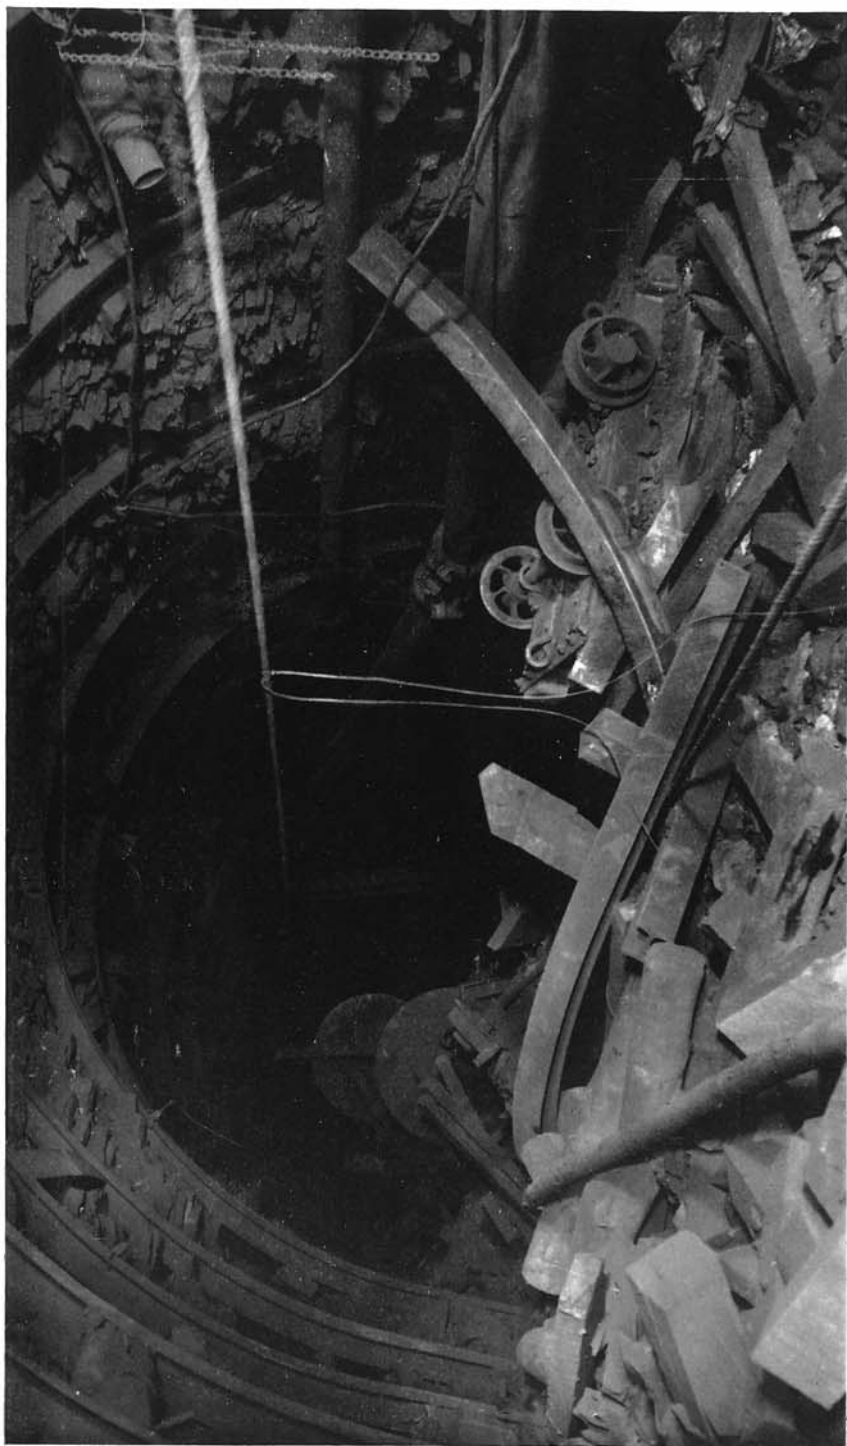
PLATE II. Return gate immediately outbye of haulage return wheel.

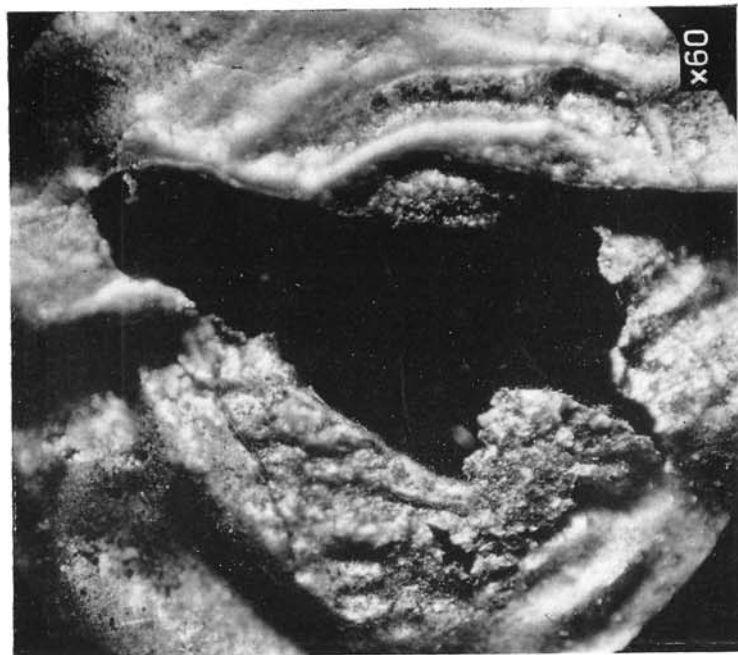
PLATE III (a). Hole in aluminum foil wrapping showing fusion of surrounding foil: as found among floor rubble in return gate 302 yards from ripping.

64. The two specimens which had signs of fusion when picked up, were found at points 302 yards and 307 yards, respectively, from the return gate ripping. The signs of fusion on these specimens were very similar to the signs on the pieces of foil which had given incensive flashes when tested.

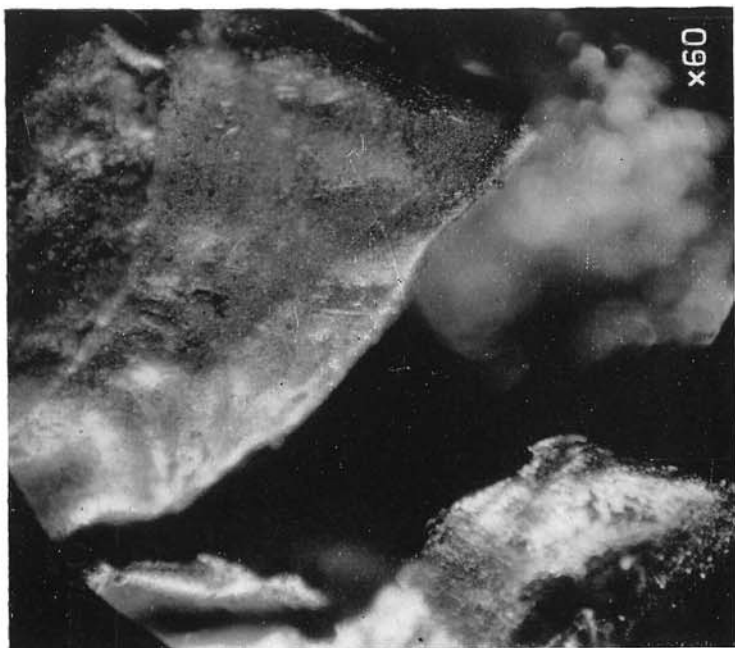
PLATE III (b). Hole in same specimen showing no fusion at edges.

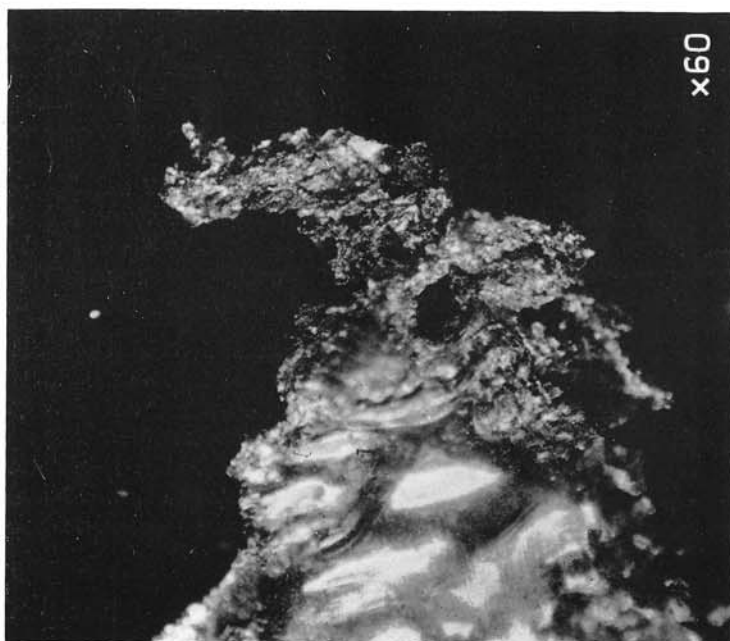
PLATE IV (a). Specimen of foil found in return gate: fusion at edge of foil after an ignition of firedamp in test with hard blow on foil in contact with rusted steel.

63. In a length of the return gate from 192 to 307 yards outbye of the ripping, 18 metal foil wrappings of a type used for confectionery and chewing tobacco were found. Nearly all the specimens were damaged by what appeared to be normal usage but two had holes, the edges of which, when examined microscopically, were found to be thin and torn, with the appearance of having been fused (*see* Plate III). When pieces from each of the specimens were submitted to glancing blows with the foil resting on rusty steel in an explosive firedamp/air mixture, ignitions were obtained with all but two of the specimens, one of which was too small to handle (*see* Plate IV). These foil wrappings, which are generally of aluminium, usually have paper backing, sometimes waxed; where this backing was retained ignition could not be obtained.

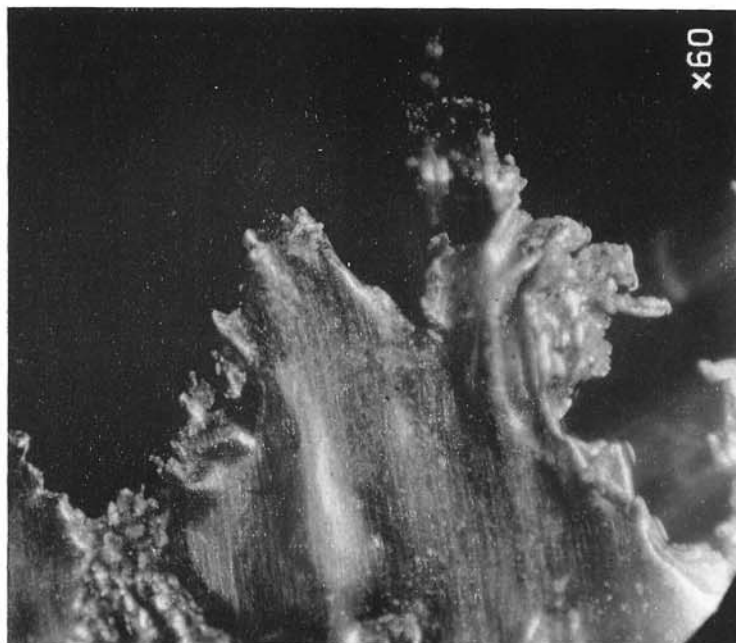
PLATE IV (b). No fusion with same specimen after a non-ignition with foil in contact with carborundum surface.
